Pressure Die Castings Image Analysis Software

Part Presentation

August 2008

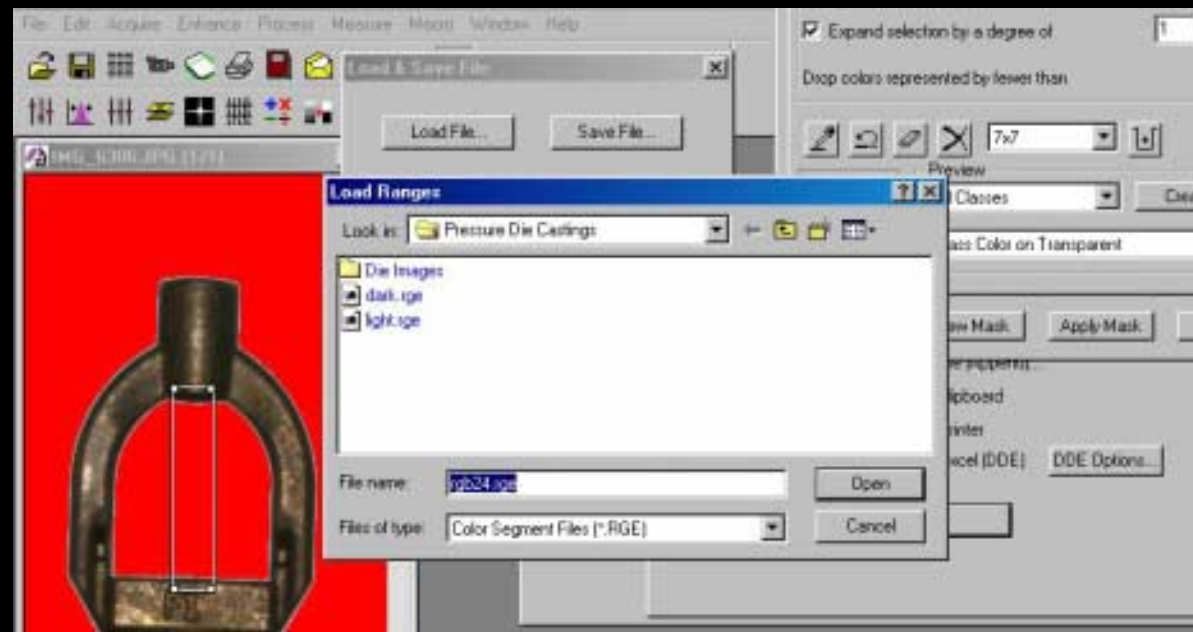
The screenshot displays the image analysis software interface. On the left, a window titled 'PDC.jpg [1/1]' shows a red mask of a bottle. On the right, a 'Data Collector' window is open, showing a table of measurements. The table has columns for 'Row/Block', 'Perm. (ratio) (Values)', 'Perimeter (Values)', and 'Perimeter2 (Values)'. The table contains 26 rows of data, with the first row being 108-108 and the last row being 121-121. A small inset window shows a close-up of the bottle's neck area.

- ◆ Image analysis software was used to process the same image a number of times.
- ◆ 121 measurements were done:
- ◆ **Std.Dev.**
- ◆ **Over all 26 measurements = 0**

CONFIRMED: The image analysis software introduces zero error

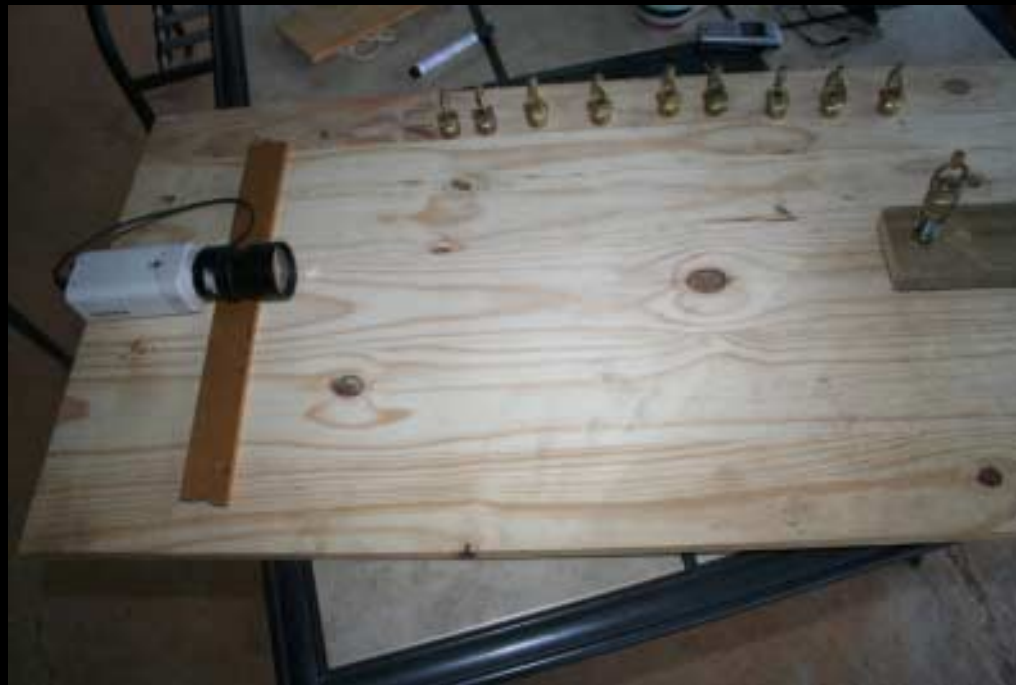
Requirement: Calculate the error introduced by the current camera configuration.

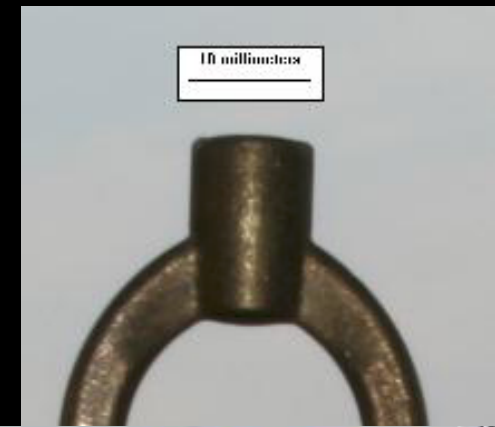
Camera Error

- ◆ Image analysis software was used to process different images of the same object, without moving the sprinkler
- ◆ All results are in MM (7 pixels per MM)

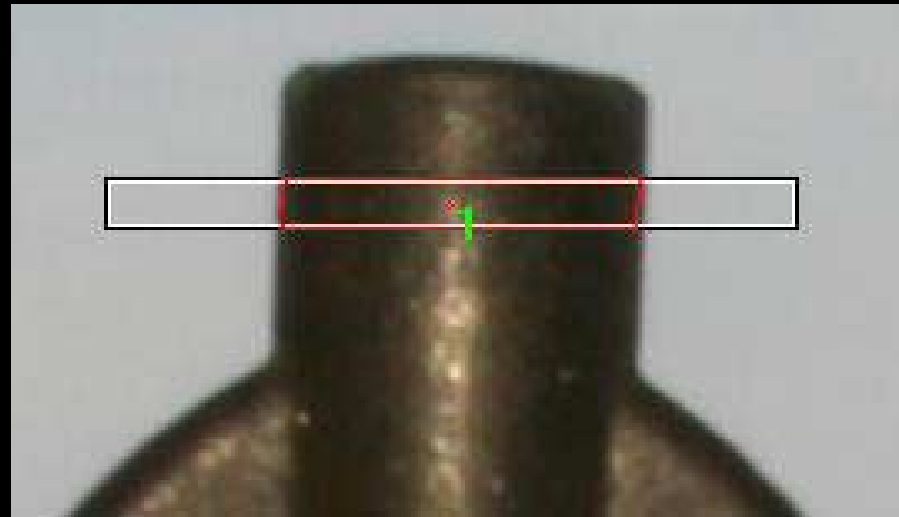
1 Boss Width (D)

IMG_6385.JPG	9.8033
IMG_6386.JPG	9.8017
IMG_6387.JPG	9.8038
IMG_6388.JPG	9.8029
IMG_6389.JPG	9.8033
IMG_6390.JPG	9.8045
IMG_6391.JPG	9.802
IMG_6392.JPG	9.801712
IMG_6393.JPG	9.802017
IMG_6394.JPG	9.801773
IMG_6395.JPG	9.802506

MAX 9.89679

MIN 9.89234

AVG 9.893094

STD DEV 0.001316

- ◆ 1 Boss Width = 0.001 mm (100X)
- ◆ 3 Spanner Flat = 0.05 mm (40 X)
- ◆ 4 NPT Boss Width = 0.00004 mm (1 000X)
- ◆ 11 Arm Angle = 0.009 degrees (50X)

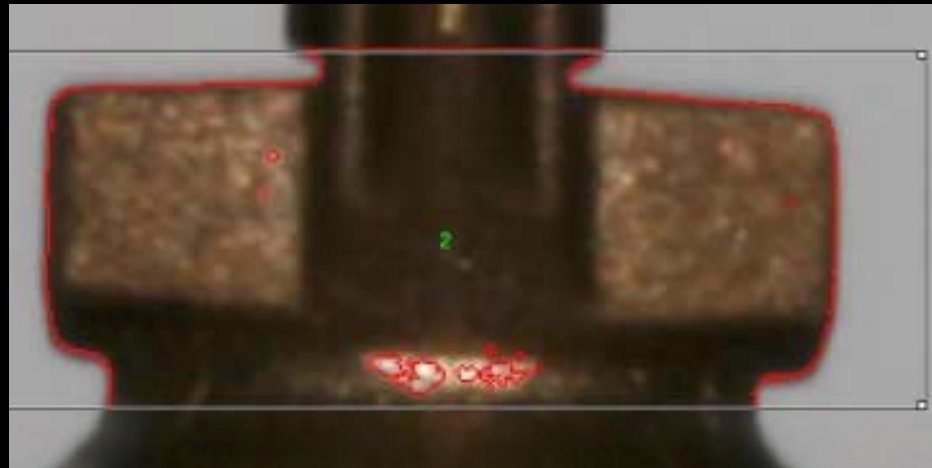
3 Spanner Flat (D)

IMG_6550.JPG	9.620819	22.96144
IMG_6549.JPG	9.620743	23.05205
IMG_6448.JPG	9.620148	23.14296
IMG_6547.JPG	9.620148	23.05209
IMG_6546.JPG	9.620178	23.05219
IMG_6545.JPG	9.6203	23.14311
IMG_6544.JPG	9.620163	23.05222
IMG_6543.JPG	9.620255	23.05217
IMG_6542.JPG	9.620773	23.05232

MAX 23.14311

MIN 22.96144

AVG 23.06228

STD DEV 0.054572

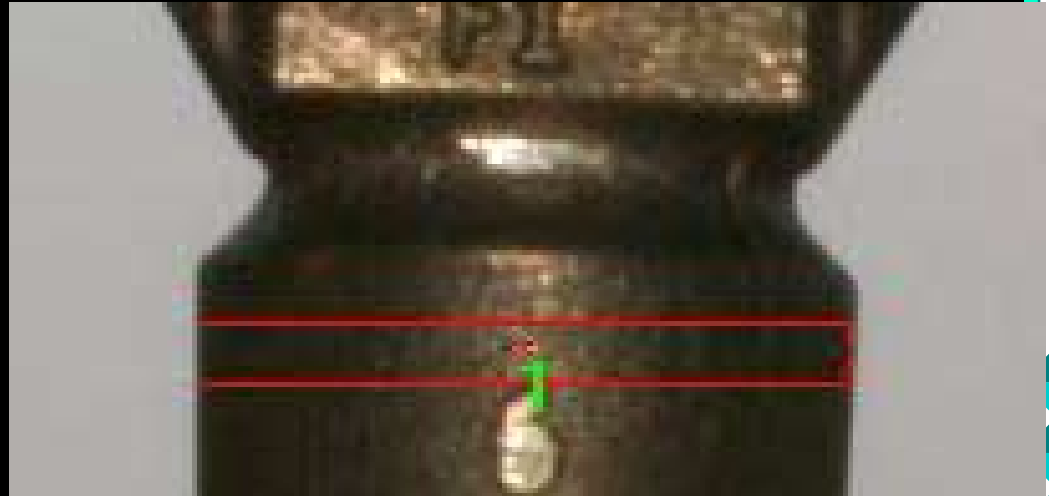
4 NPT Boss Width (D)

IMG_6560.JPG	9.89241	23.596603
IMG_6559.JPG	9.892853	23.596664
IMG_6558.JPG	9.892838	23.596741
IMG_6557.JPG	9.892868	23.596603
IMG_6556.JPG	9.892426	23.596664
IMG_6555.JPG	9.89234	23.596649
IMG_6554.JPG	9.892929	23.596603
IMG_6553.JPG	9.89679	23.59668
IMG_6552.JPG	9.892777	23.596649
IMG_6551.JPG	9.892716	23.596619

MAX 23.596741

MIN 23.596603

AVG 23.596648

STD DEV 0.00004

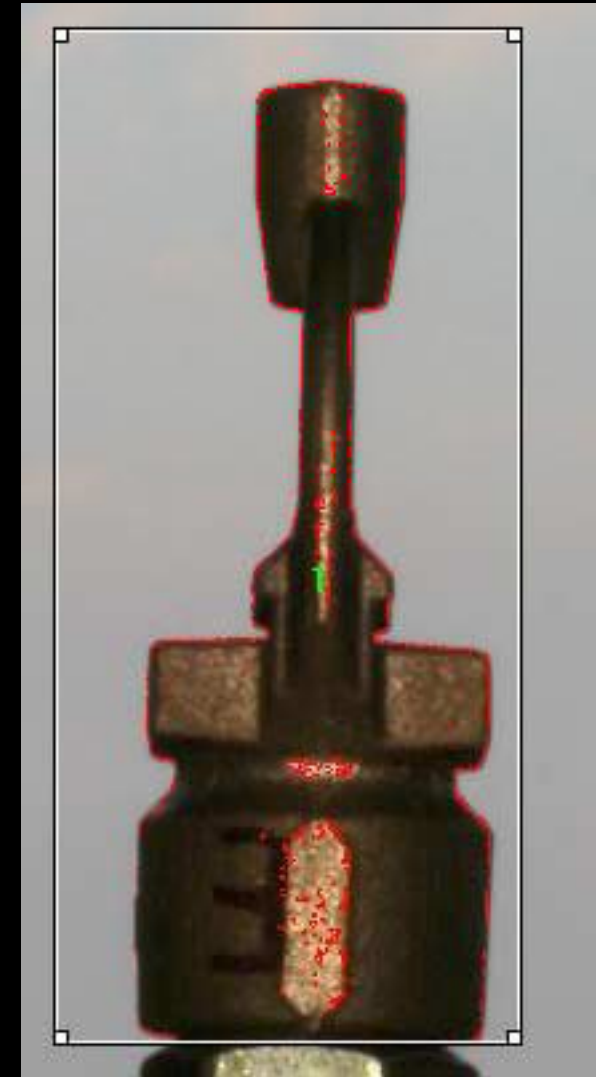
11 Arm Angle (D)

No 2	IMG_6550.JPG	9.620819	22.96144	23.687485	2.34871
No 2	IMG_6549.JPG	9.620743	23.05205	23.687469	2.33359
No 2	IMG_6448.JPG	9.620148	23.14296	23.688339	2.33551
No 2	IMG_6547.JPG	9.620148	23.05209	23.596588	2.34681
No 2	IMG_6546.JPG	9.620178	23.05219	23.687332	2.3543
No 2	IMG_6545.JPG	9.6203	23.14311	23.596573	2.35617
No 2	IMG_6544.JPG	9.620163	23.05222	23.687454	2.34642
No 2	IMG_6543.JPG	9.620255	23.05217	23.596634	2.33547
No 2	IMG_6542.JPG	9.620773	23.05232	23.59668	2.35782

MAX 2.35782

MIN 2.33359

AVG 2.34609

STD DEV 0.00932

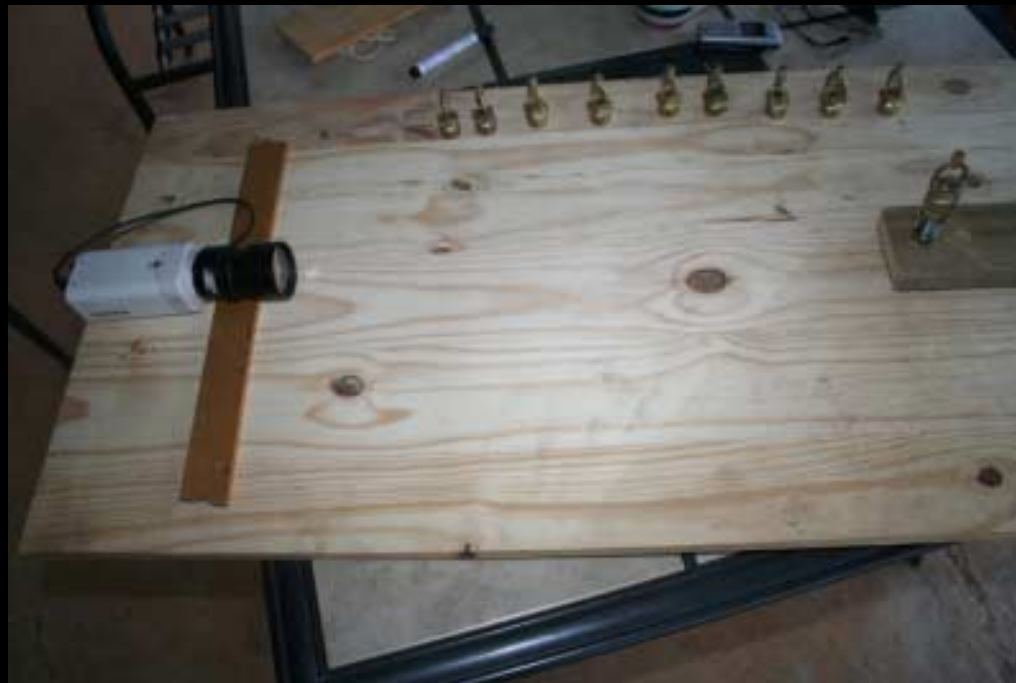
Requirement: Calculate the error introduced by the current sprinkler holder configuration.

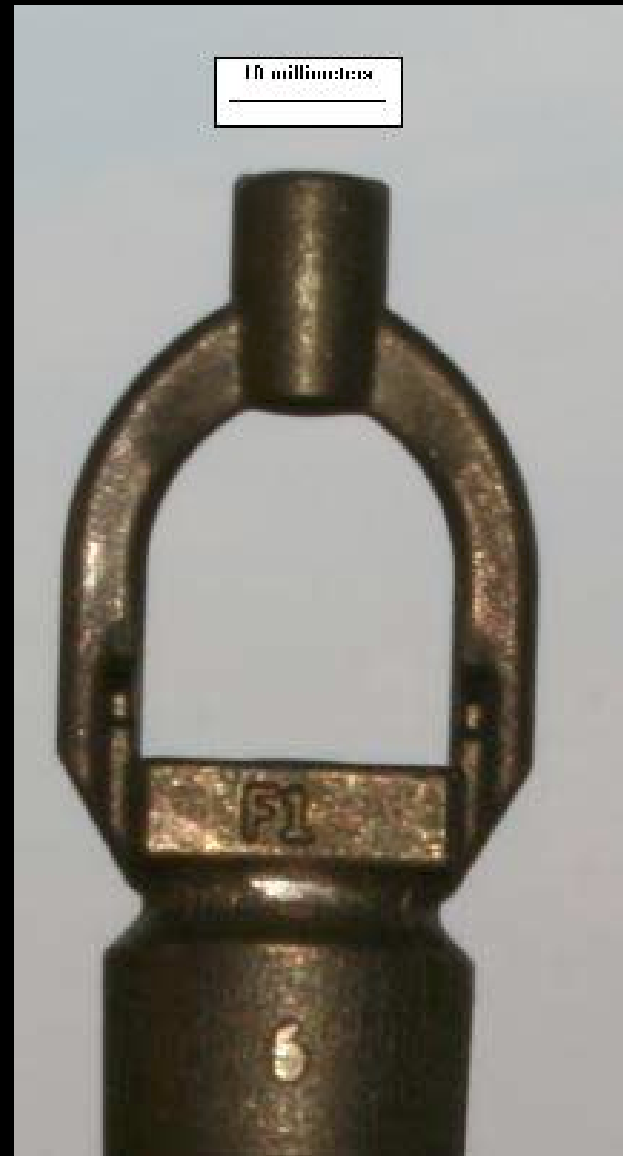
Sprinkler Holder Error

- ◆ Image analysis software was used to process different images of the same object, replacing the sprinkler in the same position on the holder each time

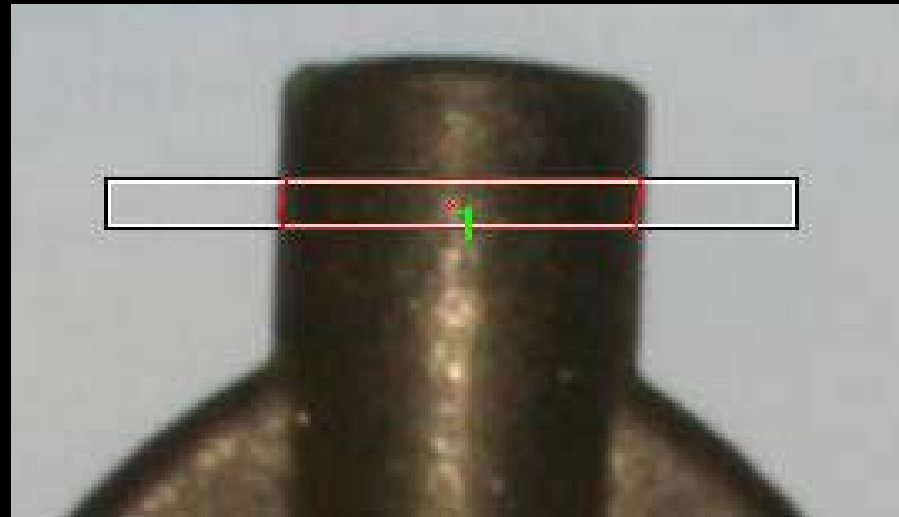
1 Boss Width (D)

1	IMG_6398.JPG	9.900665
2	IMG_6399.JPG	9.90979
3	IMG_6400.JPG	9.902832
4	IMG_6401.JPG	9.892059
5	IMG_6402.JPG	9.898117
6	IMG_6403.JPG	9.896362
7	IMG_6404.JPG	9.898239
8	IMG_6405.JPG	9.907791
9	IMG_6406.JPG	9.895783
10	IMG_6407.JPG	9.898514

MAX 9.909 MIN 9.892 AVG 9.90001

STD DEV 0.0054

◆ Less 0.001 mm camera error = 0.004 mm

- ◆ **1 Boss Width = 0.004 mm (100X)**
- ◆ **4 NPT Boss Width = 0.00054 mm (1 000X)**
- ◆ **5 Window Width = 0.002 mm (500X)**
- ◆ **6 Window Height = 0.015 mm (150X)**
- ◆ **7 Deflector Boss Length = 0.02 mm (50X)**

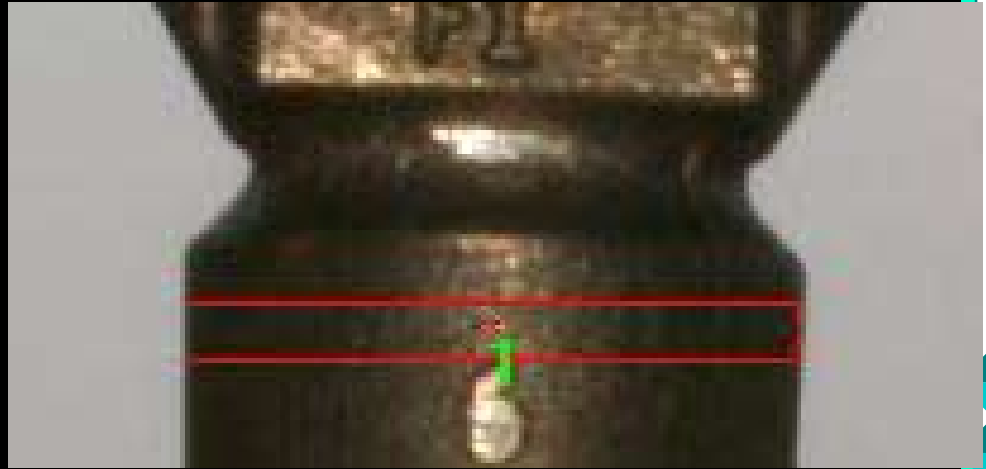
4 NPT Boss Width (D)

1	IMG_6398.JPG	9.900665	23.50592
2	IMG_6399.JPG	9.90979	23.505966
3	IMG_6400.JPG	9.902832	23.506348
4	IMG_6401.JPG	9.892059	23.505814
5	IMG_6402.JPG	9.898117	23.506317
6	IMG_6403.JPG	9.896362	23.505829
7	IMG_6404.JPG	9.898239	23.507782
8	IMG_6405.JPG	9.907791	23.505997
9	IMG_6406.JPG	9.895783	23.506439
10	IMG_6407.JPG	9.898514	23.506424

MAX 23.5077 MIN 23.5058 AVG 23.5062
STD DEV 0.00058

◆ Less 0.00004 mm camera error = 0.00054 mm

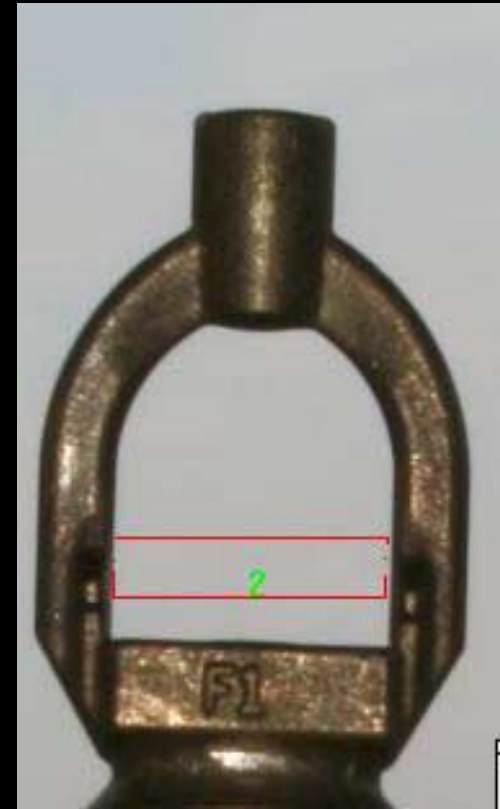
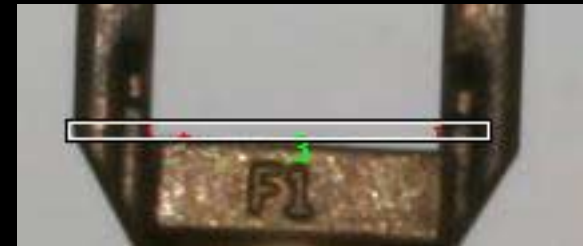
5 Window Width (L)

1	IMG_6398.JPG	9.900665	23.50592	19.15367
2	IMG_6399.JPG	9.90979	23.505966	19.15457
3	IMG_6400.JPG	9.902832	23.506348	19.1501
4	IMG_6401.JPG	9.892059	23.505814	19.14993
5	IMG_6402.JPG	9.898117	23.506317	19.14958
6	IMG_6403.JPG	9.896362	23.505829	19.14973
7	IMG_6404.JPG	9.898239	23.507782	19.14954
8	IMG_6405.JPG	9.907791	23.505997	19.15273
9	IMG_6406.JPG	9.895783	23.506439	19.1553
10	IMG_6407.JPG	9.898514	23.506424	19.15002

MAX 19.1553

MIN 19.14954

AVG 19.15152

STD DEV 0.002

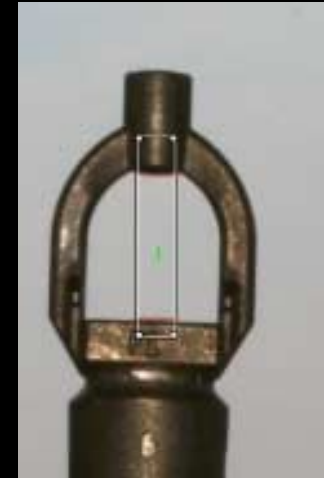
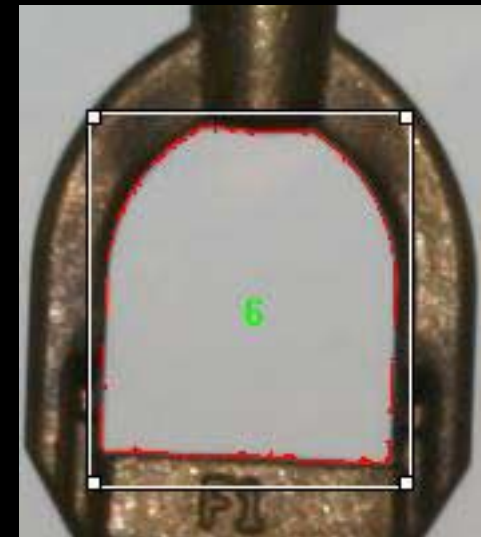
6 Window Height (L)

1	IMG_6398.JPG	9.900665	23.50592	19.15367	21.634216
2	IMG_6399.JPG	9.90979	23.505966	19.15457	21.615906
3	IMG_6400.JPG	9.902832	23.506348	19.1501	21.650757
4	IMG_6401.JPG	9.892059	23.505814	19.14993	21.651489
5	IMG_6402.JPG	9.898117	23.506317	19.14958	21.634888
6	IMG_6403.JPG	9.896362	23.505829	19.14973	21.612305
7	IMG_6404.JPG	9.898239	23.507782	19.14954	21.62146
8	IMG_6405.JPG	9.907791	23.505997	19.15273	21.634888
9	IMG_6406.JPG	9.895783	23.506439	19.1553	21.609192
10	IMG_6407.JPG	9.898514	23.506424	19.15002	21.612915

MAX 21.651489

MIN 21.609192

AVG 21.627802

STD DEV 0.015

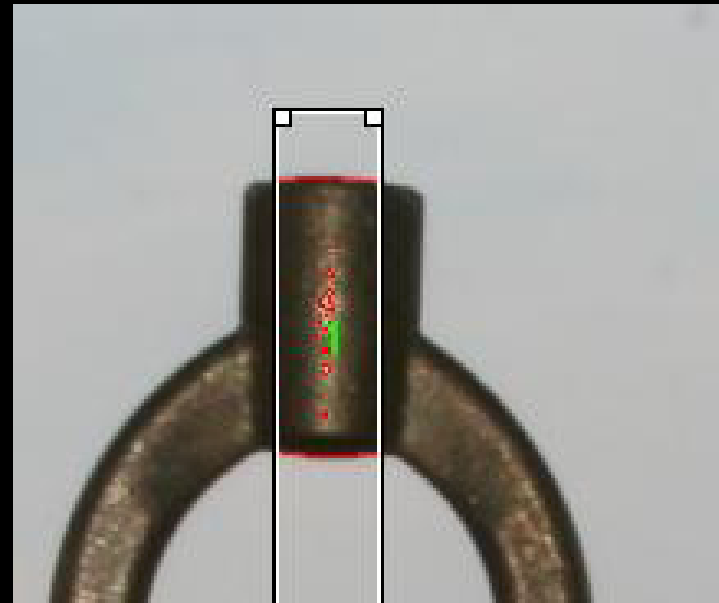
7 Deflector Boss Length (D)

1	IMG_6398.JPG	9.900665	23.50592	19.15367	21.634216	15.247559
2	IMG_6399.JPG	9.90979	23.505966	19.15457	21.615906	15.222656
3	IMG_6400.JPG	9.902832	23.506348	19.1501	21.650757	15.276001
4	IMG_6401.JPG	9.892059	23.505814	19.14993	21.651489	15.20105
5	IMG_6402.JPG	9.898117	23.506317	19.14958	21.634888	15.202026
6	IMG_6403.JPG	9.896362	23.505829	19.14973	21.612305	15.247314
7	IMG_6404.JPG	9.898239	23.507782	19.14954	21.62146	15.251221
8	IMG_6405.JPG	9.907791	23.505997	19.15273	21.634888	15.24707
9	IMG_6406.JPG	9.895783	23.506439	19.1553	21.609192	15.262085
10	IMG_6407.JPG	9.898514	23.506424	19.15002	21.612915	15.247803

MAX 15.276001

MIN 15.20105

AVG 15.240479

STD DEV 0.02
