Error Introduced by:
Image Analysis Software
Camera & Part Holder

August 2008

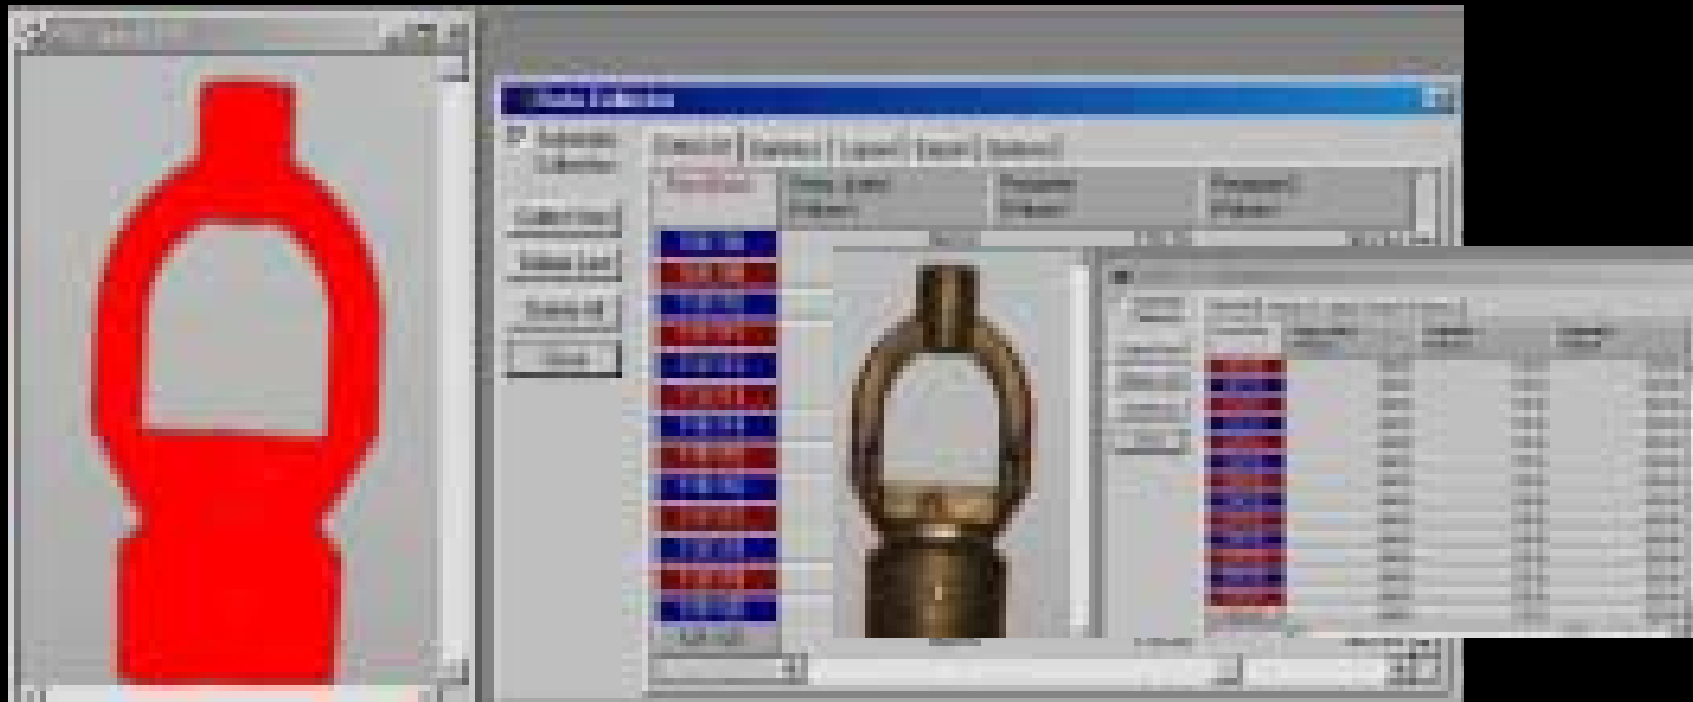
- ◆ Image analysis software was used to process the same image a number of times.
- ◆ 121 measurements were performed
- ◆ **Std.Dev. over all 26 measurements = 0**

Image Analysis Software Results

- ◆ See the attached spreadsheet document
 - 26 Measurements performed 121 times

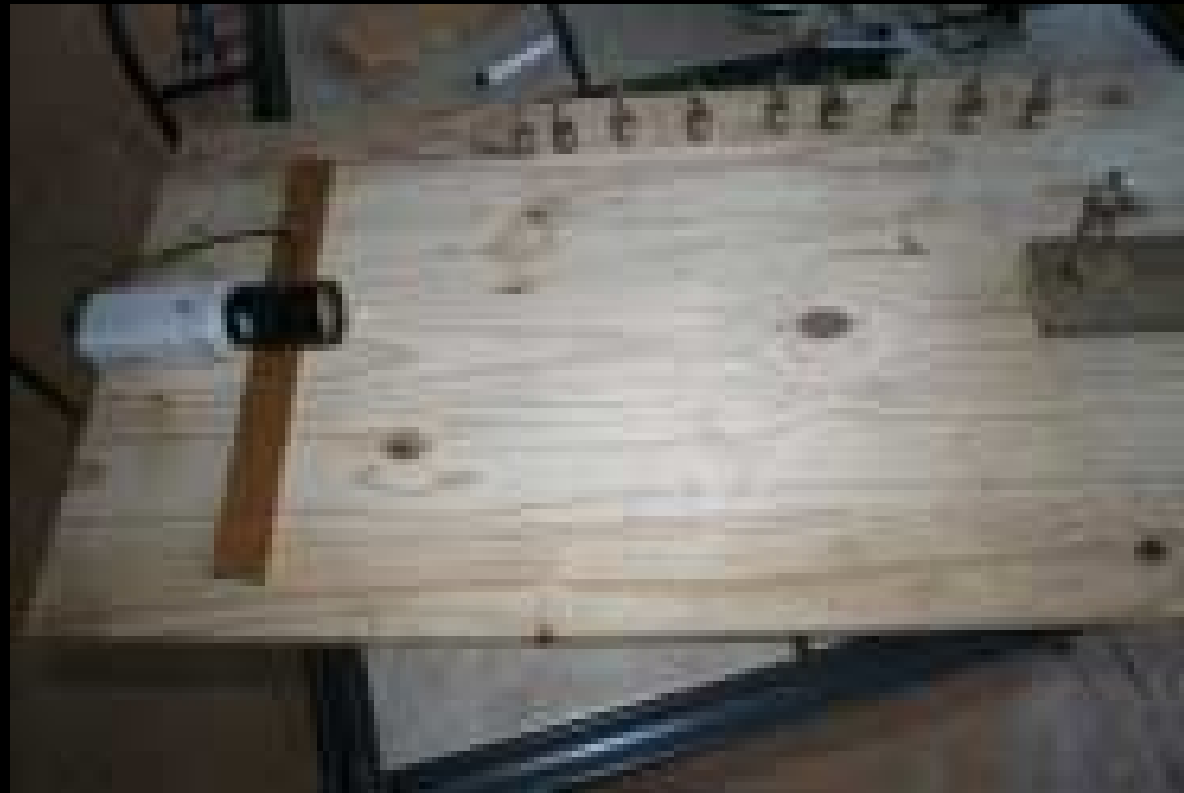
Camera / Lens Error

- ◆ Image analysis software was used to process different images of the same object, without moving the sprinkler
- ◆ All results are in MM
(7 pixels per MM)

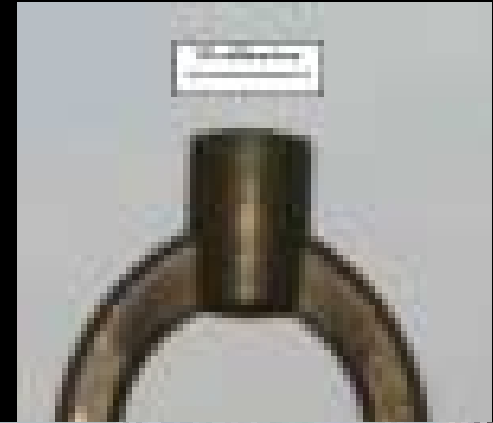
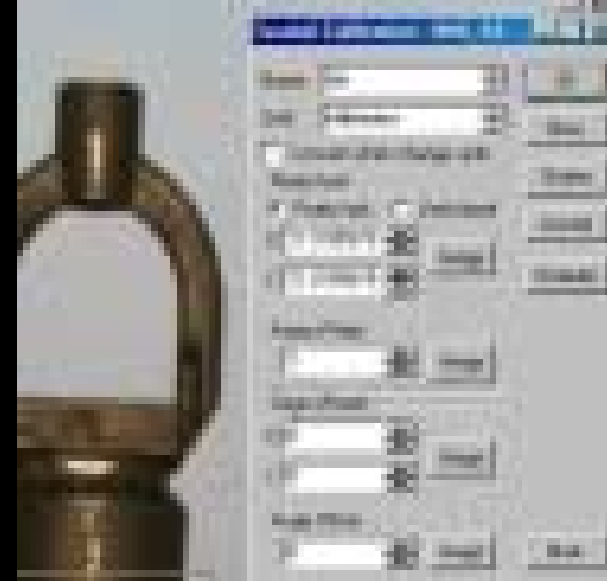
Camera / Lens Error

- ◆ The following measurements were performed:
- ◆ 1 Boss Width (D)
- ◆ 3 Spanner Flat (D)
- ◆ 4 NPT Boss Width (D)
- ◆ 5 Window Width (L)
- ◆ 11 Arm Angle (D)

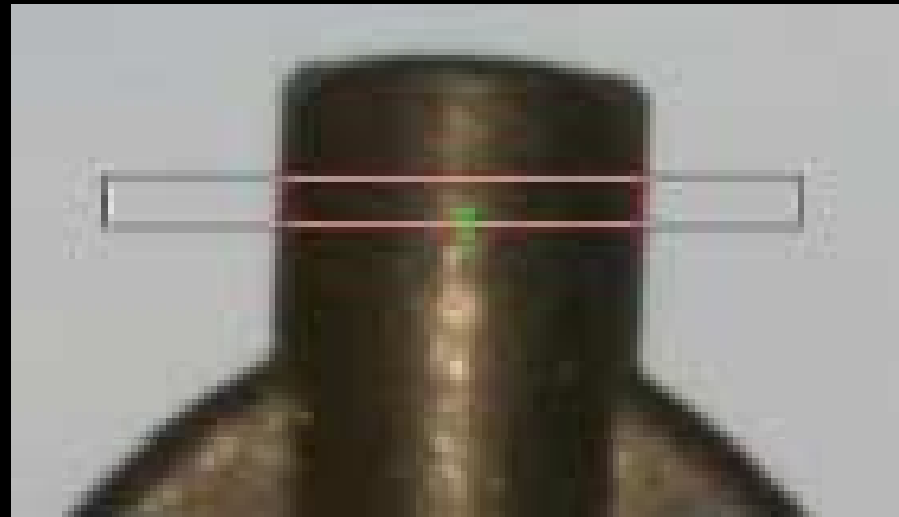
1 Boss Width (D)

MAX 9.89679

MIN 9.89234

AVG 9.893094

STD DEV 0.001316

- ◆ 1 Boss Width = 0.001 mm (100X)
- ◆ 3 Spanner Flat = 0.05 mm (40 X)
- ◆ 4 NPT Boss Width = 0.00004 mm (1 000X)
- ◆ 11 Arm Angle = 0.009 degrees (50X)

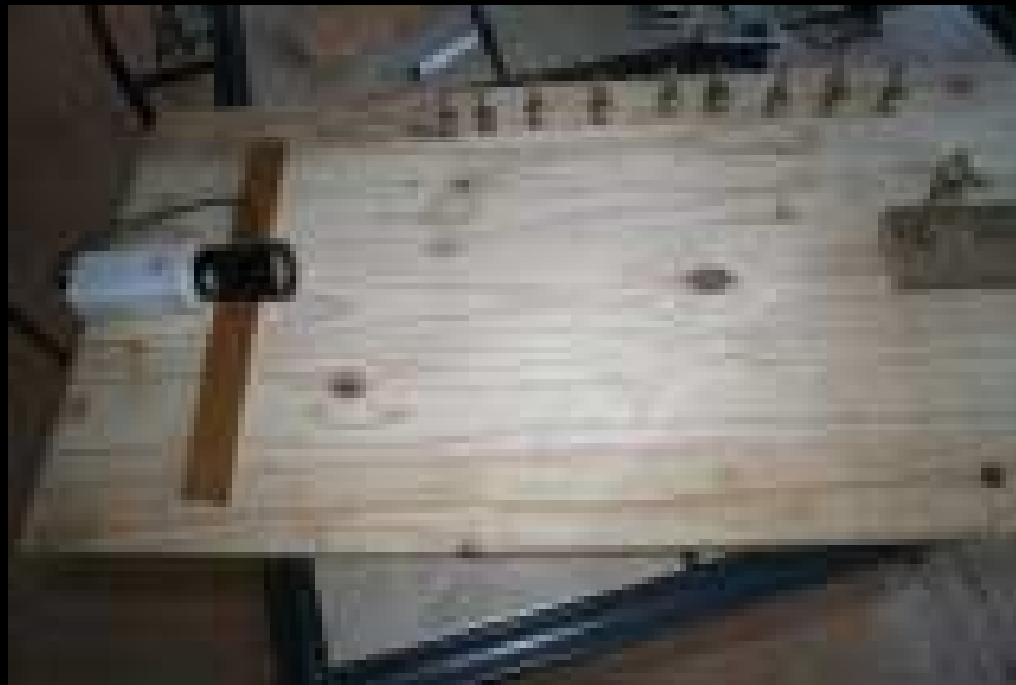
Sprinkler Holder Error

- ◆ Image analysis software was used to process different images of the same object, replacing the sprinkler in the same position on the holder each time

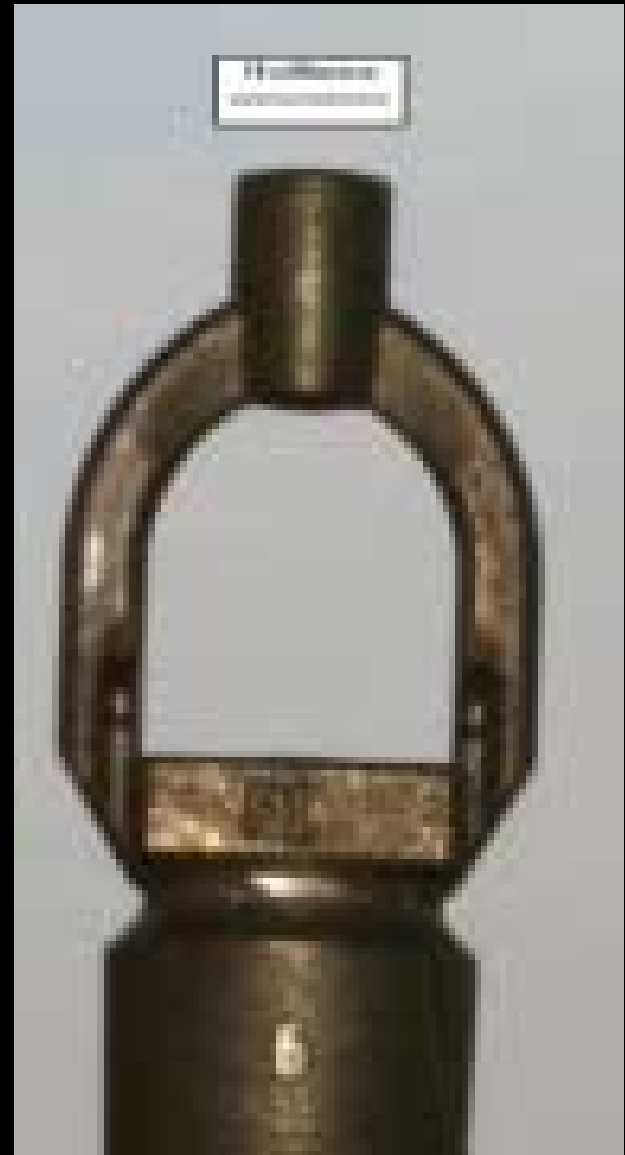
Sprinkler Holder Error

- ◆ The following measurements were performed:
- ◆ 1 Boss Width (D)
- ◆ 4 NPT Boss Width (D)
- ◆ 5 Window Width (L)
- ◆ 6 Window Height (L)
- ◆ 7 Deflector Boss Length (D)

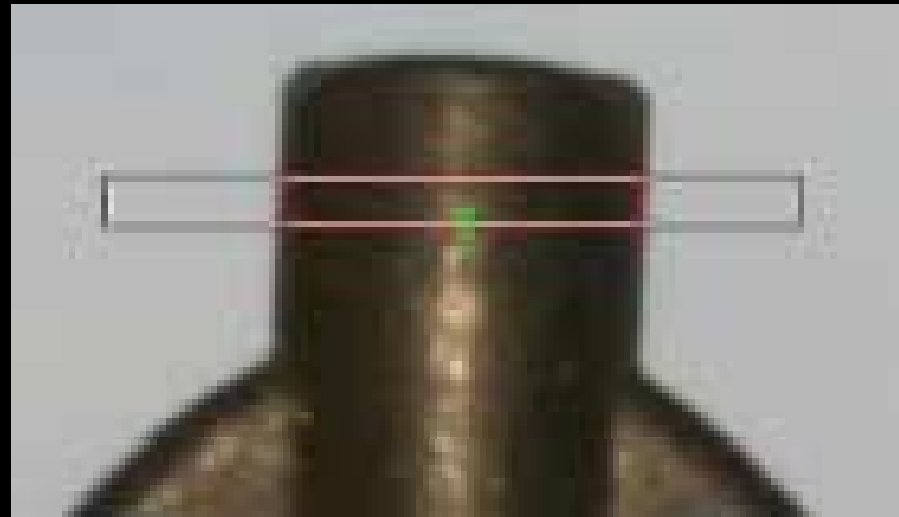
1 Boss Width (D)

MAX 9.909 MIN 9.892 AVG 9.90001

STD DEV 0.0054

◆ Less 0.001 mm camera error = 0.004 mm

- ◆ **1 Boss Width = 0.004 mm (100X)**
- ◆ **4 NPT Boss Width = 0.00054 mm (1 000X)**
- ◆ **5 Window Width = 0.002 mm (500X)**
- ◆ **6 Window Height = 0.015 mm (150X)**
- ◆ **7 Deflector Boss Length = 0.02 mm (50X)**

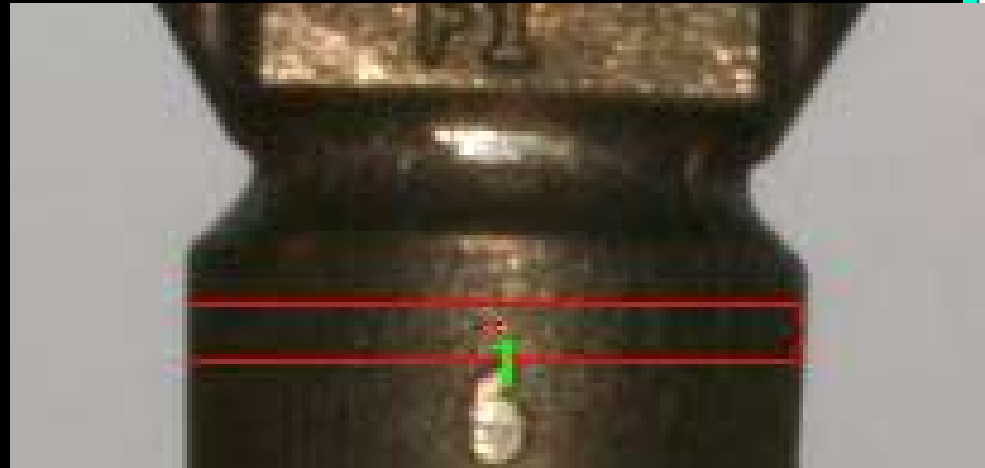
4 NPT Boss Width (D)

MAX 23.5077 MIN 23.5058 AVG 23.5062
STD DEV 0.00058

◆ Less 0.00004 mm camera error = 0.00054 mm

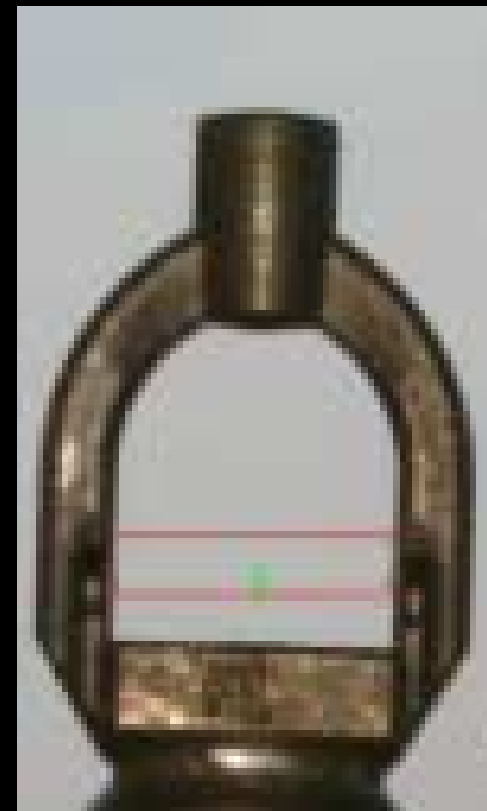
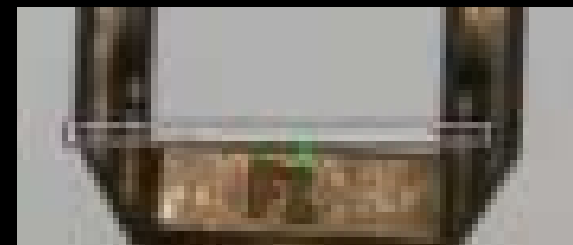
5 Window Width (L)

MAX 19.1553

MIN 19.14954

AVG 19.15152

STD DEV 0.002

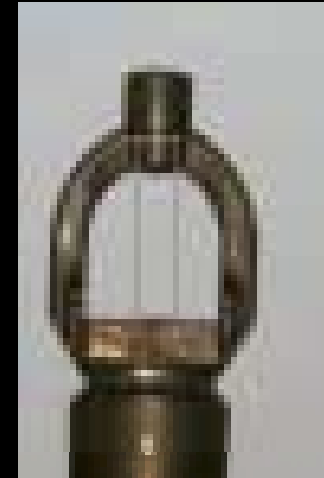
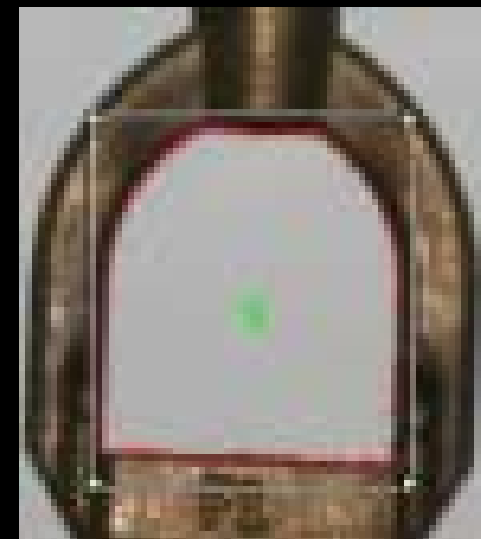
6 Window Height (L)

MAX 21.651489

MIN 21.609192

AVG 21.627802

STD DEV 0.015

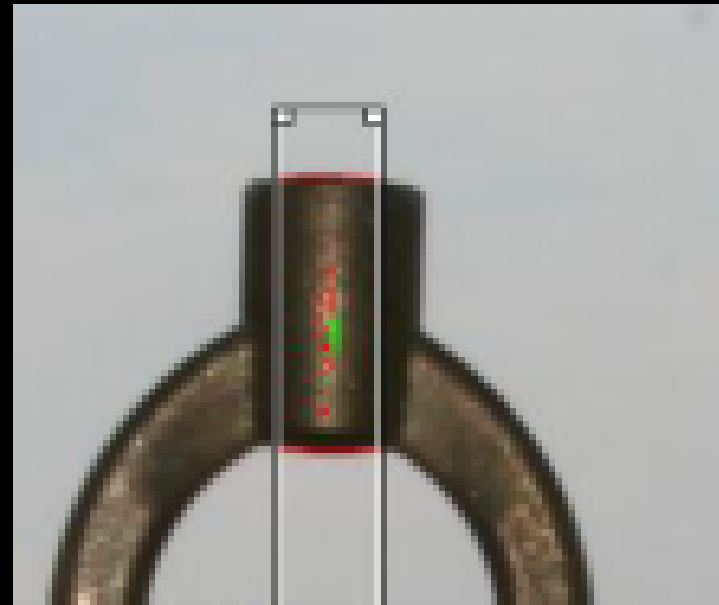
7 Deflector Boss Length (D)

MAX 15.276001

MIN 15.20105

AVG 15.240479

STD DEV 0.02
